Fallingwater Is No Longer Falling

By Gerard C. Feldmann, P.E.

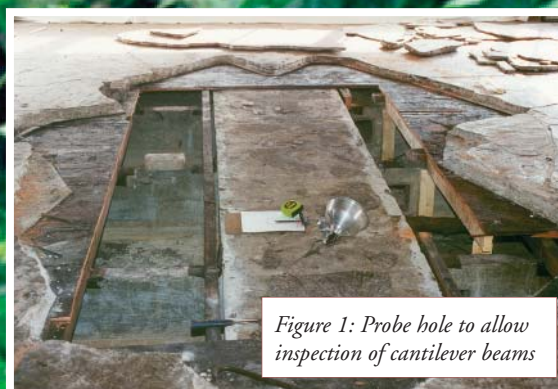
Figure 1: Probe hole to allow inspection of cantilever beams

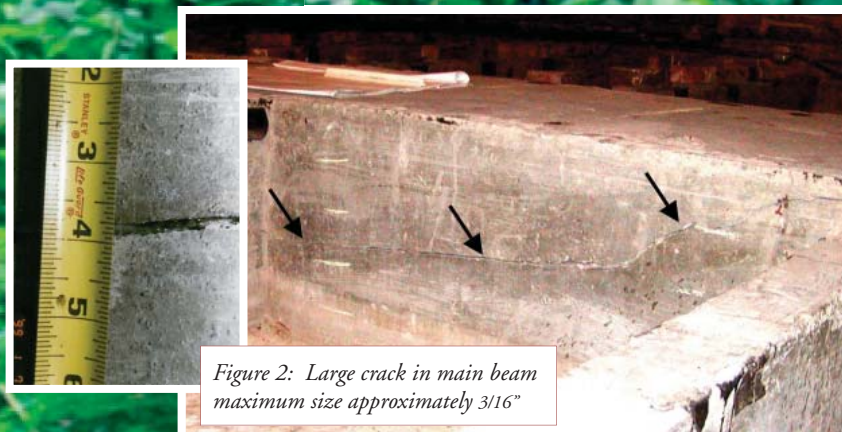
Figure 2: Large crack in main beam maximum size approximately 3/16"

The pre-design non-destructive testing and probing established some of the parameters for the preliminary design. The initial probing was limited to non-destructive radar testing with a small hole and limited access under the floor. The floor was opened up further to allow more intensive observation and testing. (See Figure 1) Cores were taken from the beam to establish a compressive strength for the concrete. This work also established the amount of reinforcement in the beams, which had been a matter of contention during the original construction. (See Robert Silman's sidebar) It was during this probing that the first surprise occurred. A crack was discovered that effectively created a plastic hinge on the center cantilever beam at the face of the pier below. (See Figure 2)

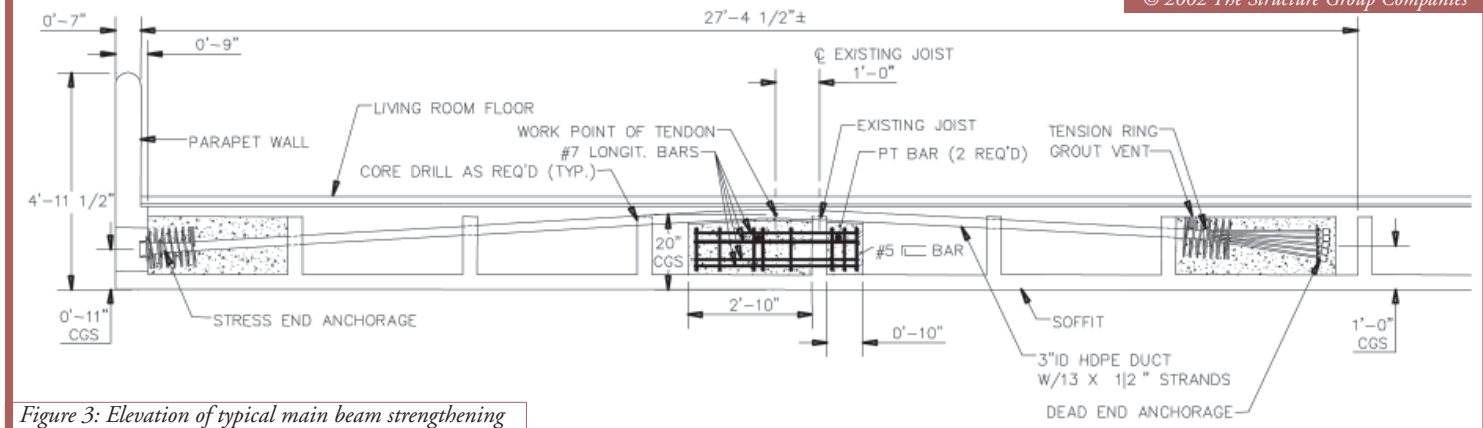
Figure 3: Elevation of typical main beam strengthening

A bonded, multi-span system was used for the main beams and a monostrand system was utilized on the joists. The final strengthening design resulted in the following tendons and forces on the three main cantilever beams: West and Center: 26 strands, 780 kips; East: 10 strands, 300 kips. See Figure 3 for a typical elevation of the strengthening system. The post-tensioning stressing, diverter and dead-end blocks for the main beams were

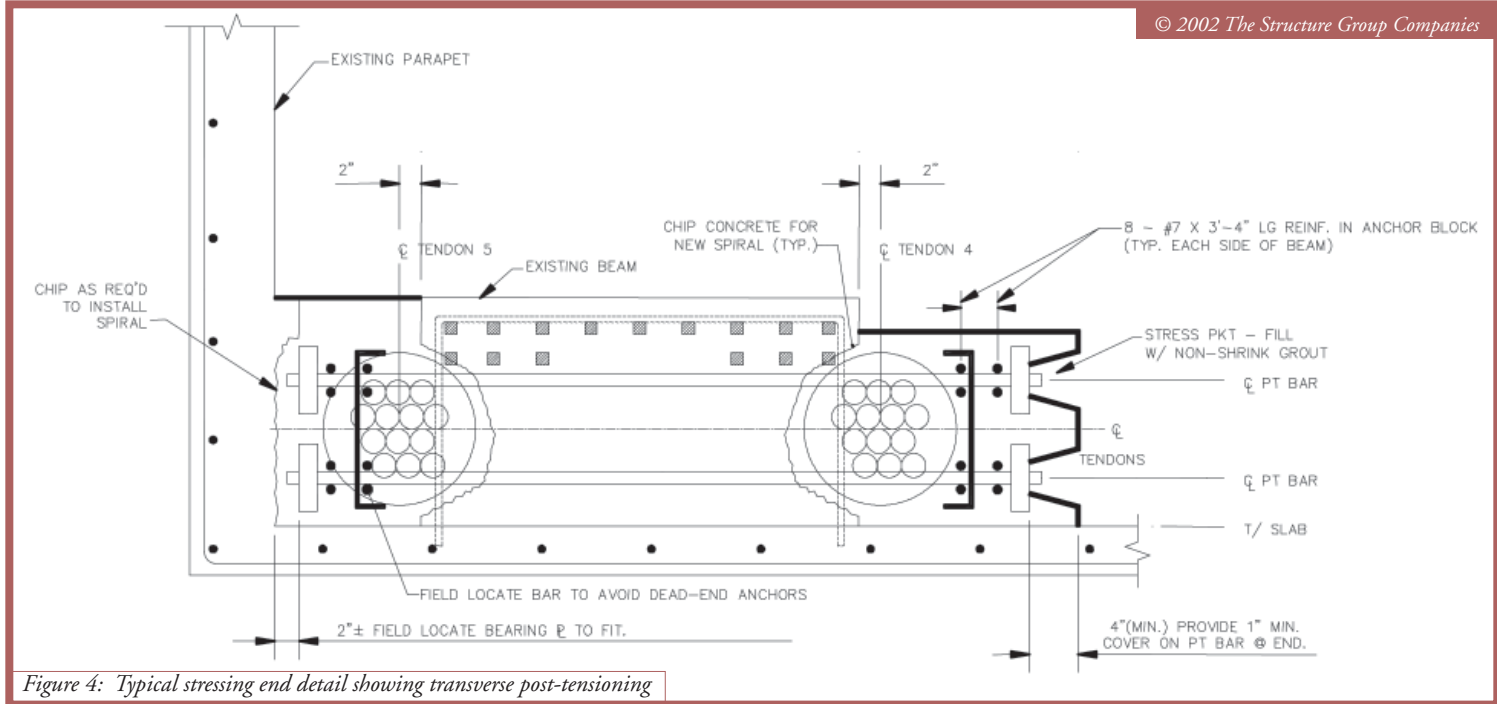
Figure 4: Typical stressing end detail showing transverse post-tensioning

also transversely post-tensioned to prevent splitting from the large horizontal forces. See *Figure 4* for the anchor block detail. The monostrand force was 43 kips per strand. The bearing ends of the cantilevers were more securely anchored to the piers below by coring and grouting rock anchors since the existing reinforcement in that location was found, from historic photos and radar investigation, to be minimal.

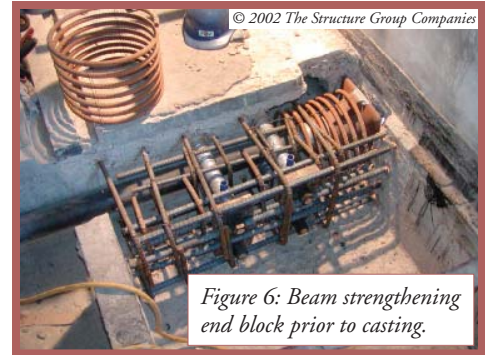
Figure 6: Beam strengthening end block prior to casting.

The installation of the main external post-tensioning proceeded. Cores were made through the parapets and perpendicularly through the main cantilever beams at the stressing and dead ends and at the high-point tendon deviations. *Figure 6* shows the typical reinforcement of the stressing end anchorage prior to casting. *Figure 7* shows the main post-tensioning in the process of being stressed.

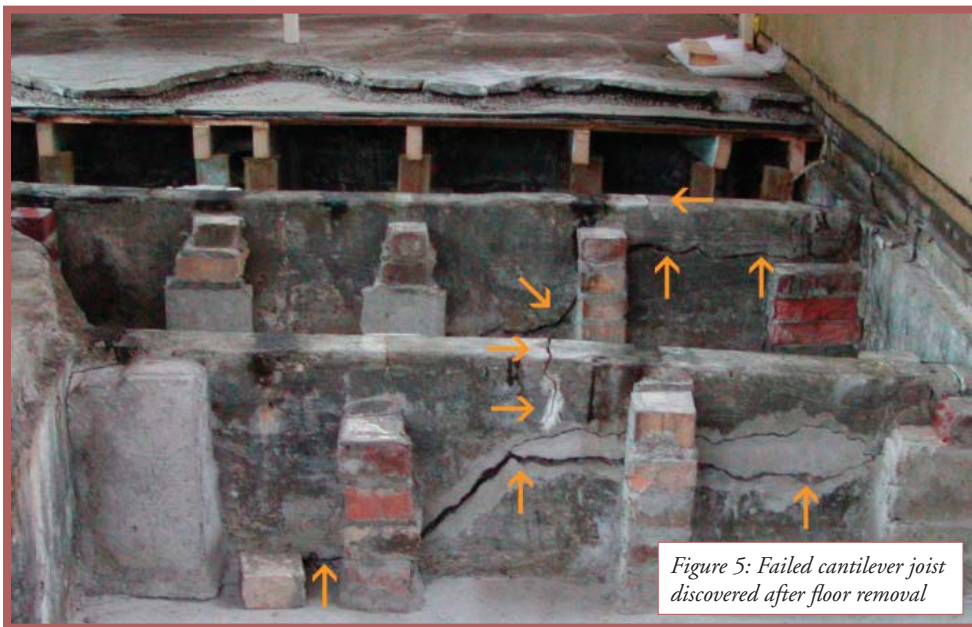
a time consuming project in itself as each piece of stone had to be cataloged to find its place again during replacement, uncovered other structural damage. The east side joist cantilevers were found to have effectively failed with large cracks. (See *Figure 5*) These joists were beyond repair, and were removed and replaced. Additional external post-tensioning was added in this location as well.

Figure 5: Failed cantilever joist discovered after floor removal

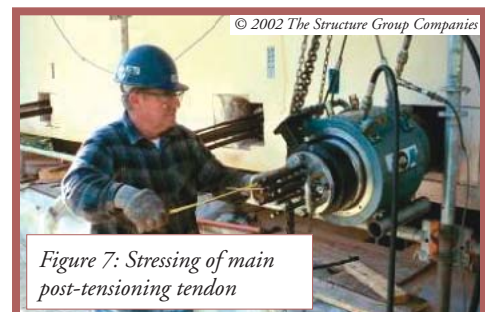
Figure 7: Stressing of main post-tensioning tendon

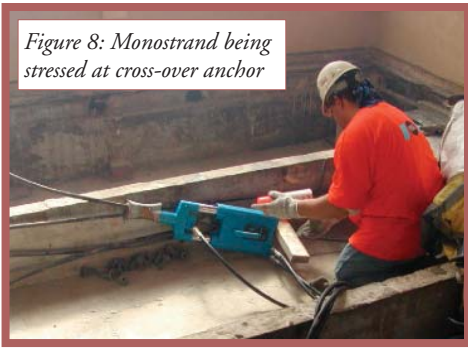
Figure 8: Monostrand being stressed at cross-over anchor

The contractor suggested an alternate monostrand system for the east-west joists that utilized a crossover anchorage. This negated the need to core through the parapets and, thus, preserved the original structure. The main tendons were stressed incrementally over three days to slowly apply the large forces to the structure. *Figure 8* shows the crossover anchorage being stressed. The parapet penetrations were patched by SPS to within a 1/4 inch of the surface to allow restoration specialists to patch the remaining material to match the surrounding finish of stucco and paint. The completed repairs are invisible to the eye. *Figures 9* and *10* show the restored interior and exterior, respectively. (See page 50 for *Figure 10*).

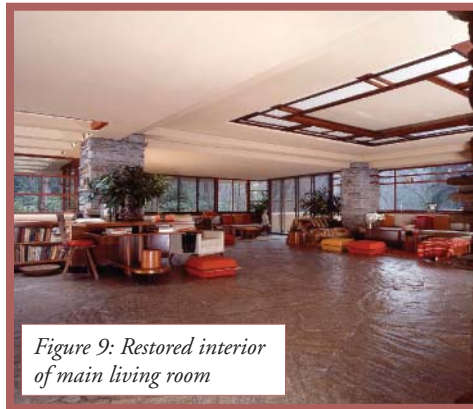
Figure 9: Restored interior of main living room

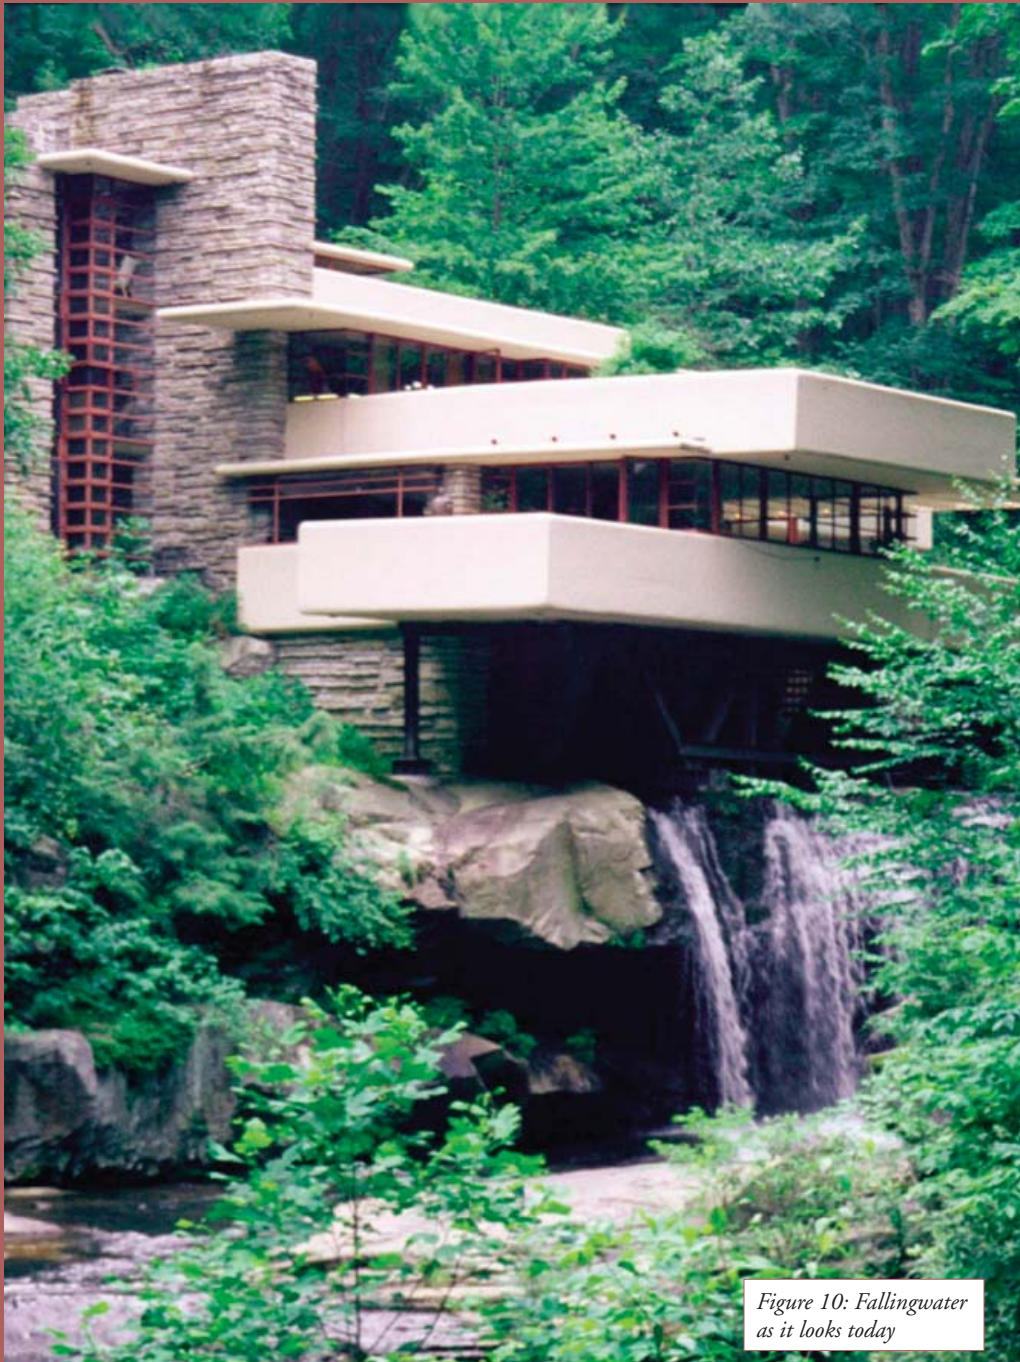
Figure 10: Fallingwater as it looks today
